# **VANDERBURGH COUNTY MS4 GOOD HOUSEKEEPING**

Facility Inspection Report for:

## **VANDERBURGH COUNTY CORONER'S OFFICE**

Report Completed: February 2010

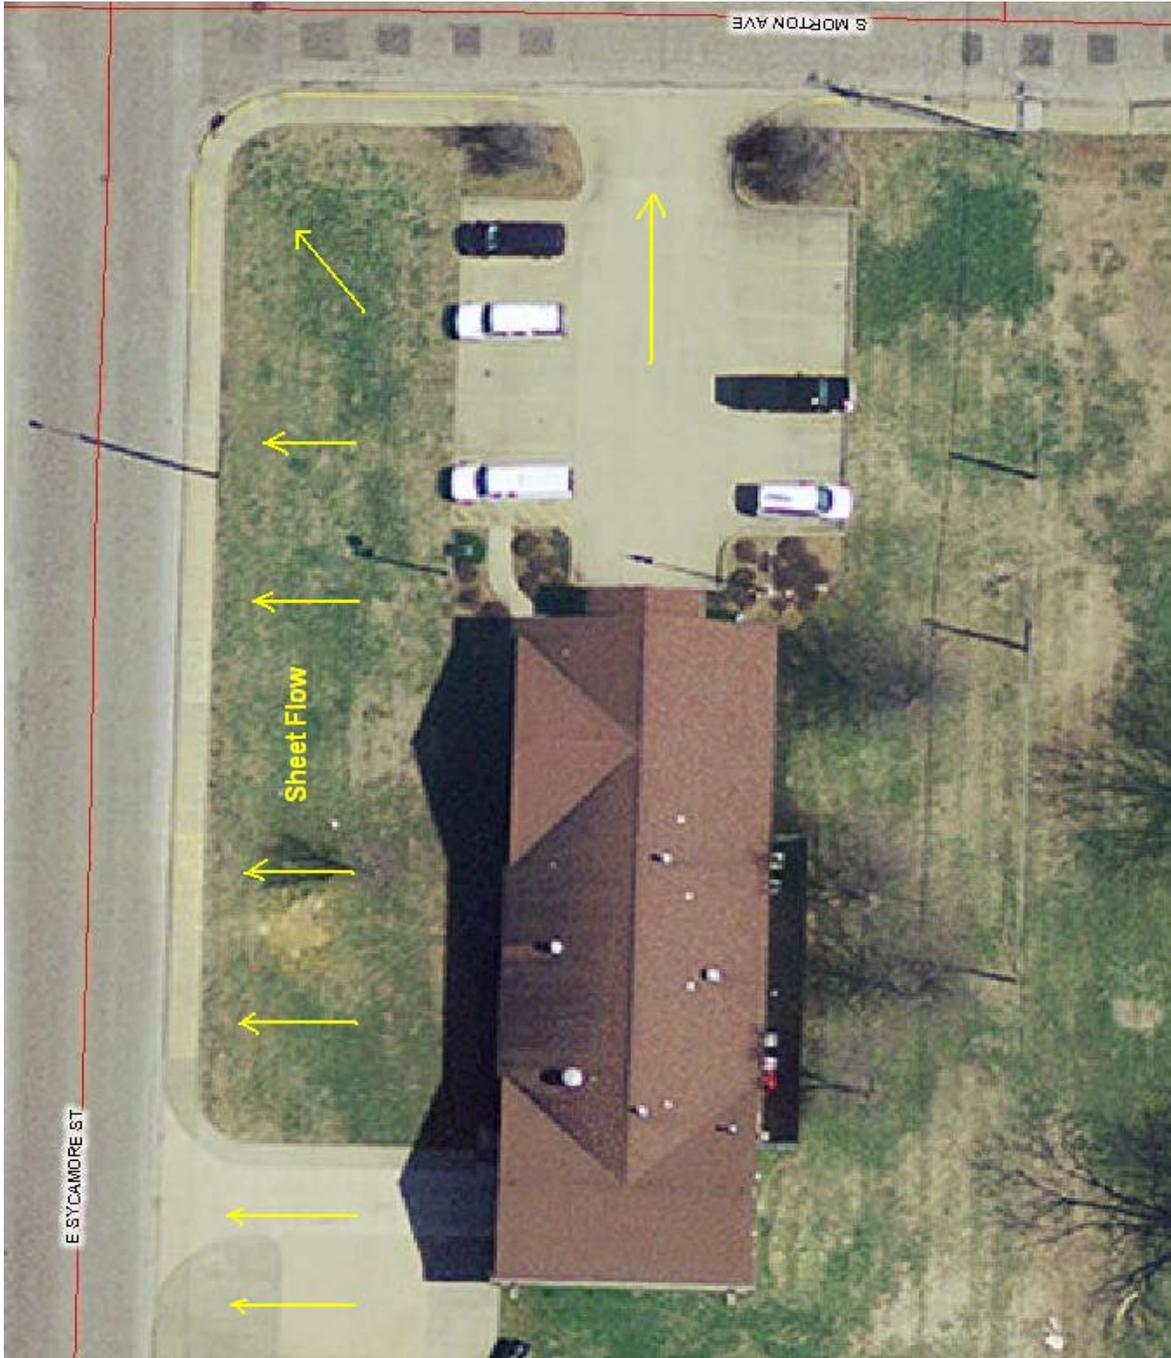
**Figure 4 – Drainage Pattern at Coroner’s Office**

This facility is located at the southwest corner of Sycamore Street and Morton Avenue near downtown Evansville, Indiana. This entire site drains via sheet flow to Morton Avenue and Sycamore Street. This runoff is then collected into curb inlets. These inlets and their associated storm sewers are part of the City of Evansville’s MS4 system. An aerial view of this drainage pattern is shown in Figure 4.

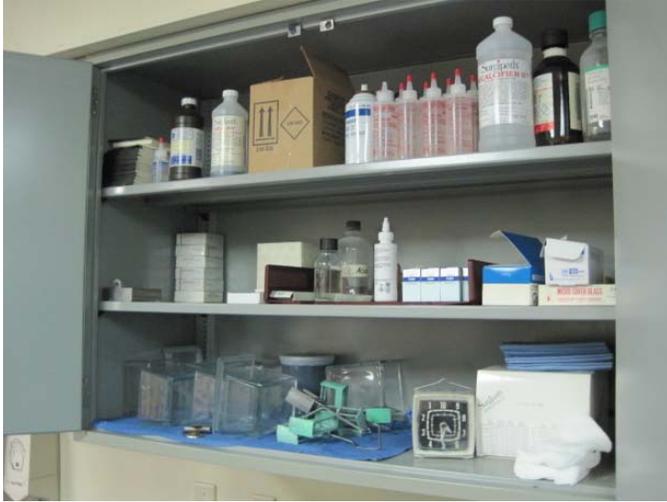
The on-site materials storage at the Coroner's Office consists of numerous compounds required for performing autopsies, as well as disinfectants, cleaners, etc. Due to the wide variety of materials, they are too numerous to list in this report. Photos of the typical storage areas and methods for these materials are shown in Figures 4, 5, and 6. All of these materials are stored indoors. As can be seen in these photos, these materials typically are stored in one gallon or smaller bottles.

**Figure 4 – Materials Stored in the Coroner's Office**

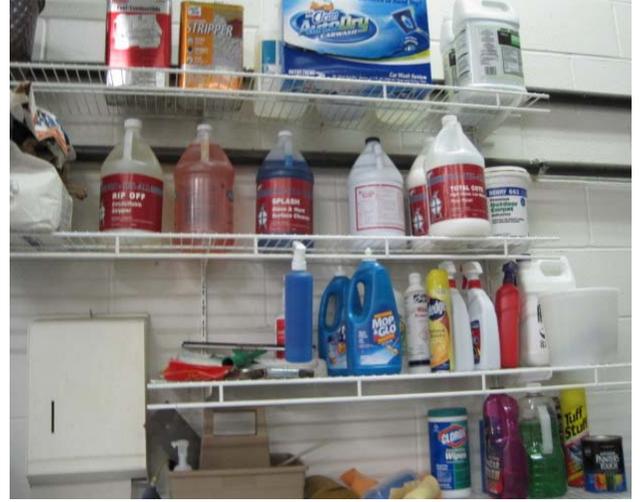
**Figure 5 – Typical Cleaners Stored in Coroner's Office**

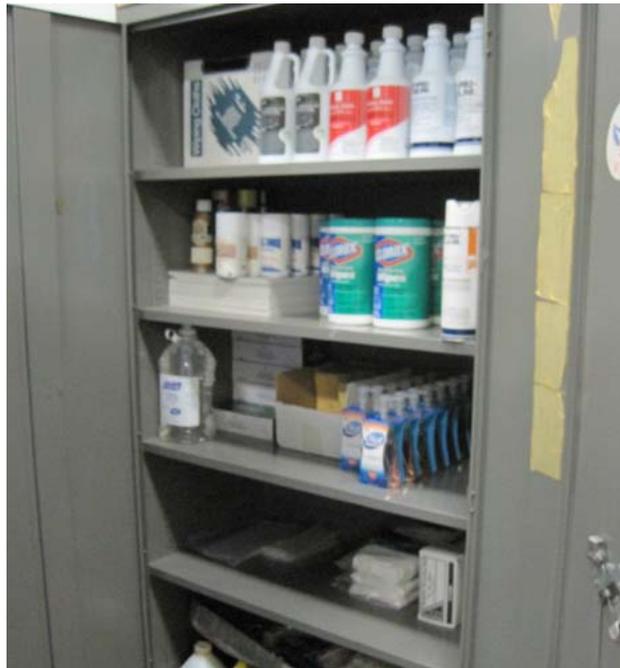
**Figure 6 – Typical Storage Facility at Coroner's Office**

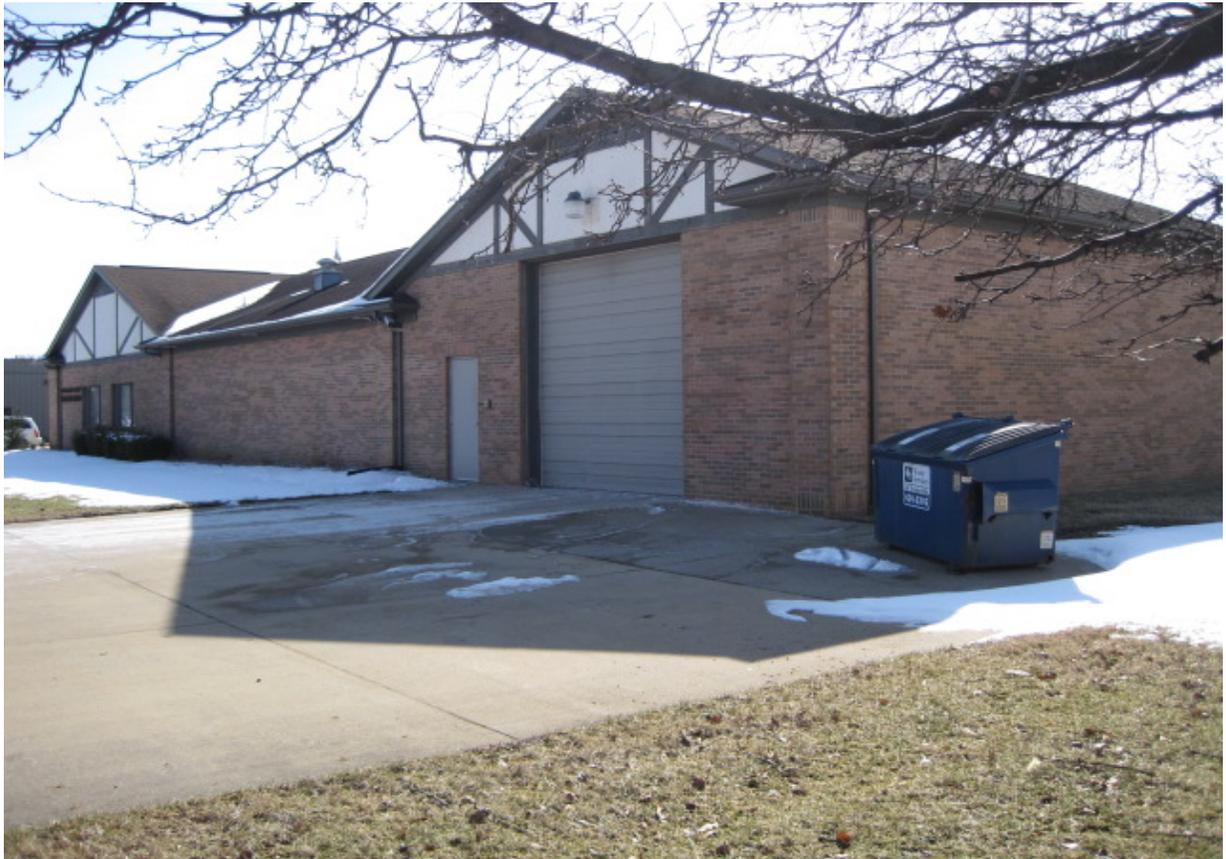
- 2) Dumpster      There is a metal garbage dumpster located near the northwest corner of this facility as shown in Figure 7. Potential pollutants likely to be found at this source primarily consist of general office waste that could become floatable debris if it is not contained within the dumpster.

**Figure 7 – Dumpster Located Near the Northwest Corner of the Coroner's Office**

The amount of materials present at the Coroner's Office that pose a risk to the quality of storm water runoff is negligible. The potential pollutants utilized at this site are stored indoors and therefore do not pose a potential risk of being exposed to storm water if spilled. All of the chemicals, disinfectants, cleaners, etc. are used within the building, and as a result are disposed of through the sanitary sewer system. Once the containers of the materials are empty, they are disposed of in the covered dumpster. The pollutant sources on the exterior of the building primarily consist of vehicular fluids and floatable debris. This dumpster is covered, which minimizes the risk that anything placed in the dumpster will enter the storm drainage system during rain events. The automotive fluid pollutants that are likely to be found on the on-site parking lot and that have the potential to be found in the first flush period of storm water runoff are discharged into a paved city street that collects immediately into combined sewer curb inlets and is subsequently treated at a municipal wastewater plant (except during CSO events). Based on this inspection, no additional storm water quality best management practices are currently needed for this facility.
